The Mitigation Of Coastal Abrasion On Islands, Special Reference To The Kodingareng Keke Island Makassar City, Indonesia

Kaharuddin, Ratna Husain, Busthan

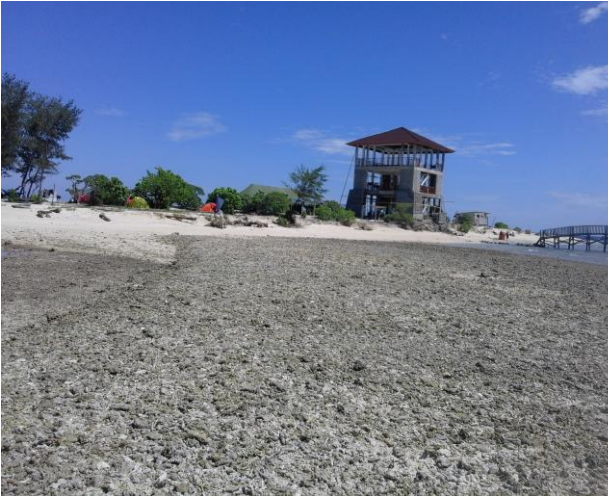
The coast of Kodingareng Keke Island are shallow waters area with varying depths ranging from 2 to 20 meters. The composed of islands are of coral reef organisms fragments that are clearly visible during low tides of exposure, especially in western waters formed by erosion and sedimentation processes (Fig. 2).

Fig. 2. Illustrates the material of the island composed of coral reef destruction

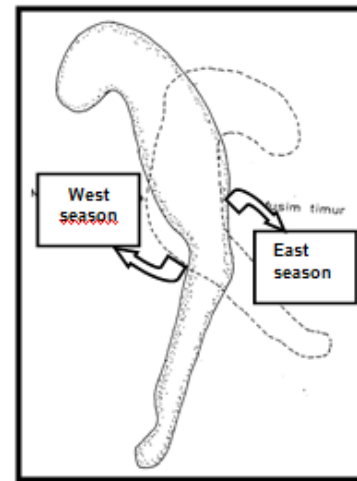
The west wind during the west season (October-April) causes the movement of waves from southwest to northeast and from south to north, in this region will occur erosion, especially the sand island body. Further in the north and north-east where there is wave diffraction accompanied by the deposition of the sediment transport material of the wave and the shoreline currents, causing the shape of the island to curve eastward.

On the east season (June-March) movement of the waves from southeast to northwest and east to west, so on the south and east of the island there is a wave diffraction accompanied by sedimentation of sedimentary material, causing the form of a curved island to the west (Bloks and Mappa, 1986) . Fig.3

Fig. 3. Changes in the shape of Kodingareng Keke island in the west and east seasons (Bloks and Mappa, 1986).

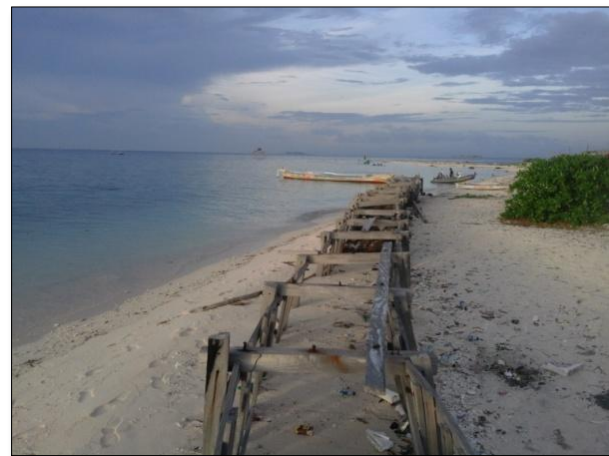
research in 2008.
Fig. 5. Seawall made of wood damaged as a result waves hit in the west season

Has been carried out by the residents of Kodingareng Keke Island to cope with coastal abrasion such as planting protective trees, coral piles around the abrasion area, the installation of stoned piles filled with stones and others, but all failed to ward off the ferocious waves eroding the shore, trees and ignited rocks (Figure 5).

On the ground there was a public effort and the government built seawall from the ironwood pegs and on the inside of the island filled with boulder rocks of a kind of basalt rock, but its durability has not been tested because based on observations at the time of the east season where seawall is placed to the west of the southern edge sedimentation island. So have to wait for the west season whether to survive or not.

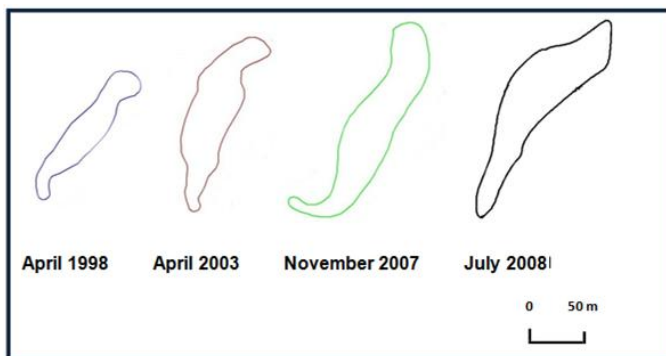
The occurrence of this change is strongly influenced by the activity of currents and waves in each season, especially in the west season which causes the erosion and deposition on the other side every year, so that the change of shape, extent and position (Sirajuddin, 2011). Kodingareng Keke Island, based on the interpretation of satellite imagery, has increased the extent, shape and position due to coast dynamics activities and geological processes (Table 1 and Table 2 and Figure 4).

Fig. 4. Changes in morphology of Kodingareng Keke Island based on satellite image interpretation (1998, 2003, 2007) and fieldwork (2008); (Sirajuddin, 2011).
